Road Improvement: Reconditioning of Gutierrez Street in Paraná

Nahuel Mussin¹ – Máximo Borghello² – Simón Vitale³

Civil Engineering Department, Facultad Regional Paraná, Universidad Tecnológica Nacional
1033 Almafuerte Av, Paraná Entre Ríos, Argentina

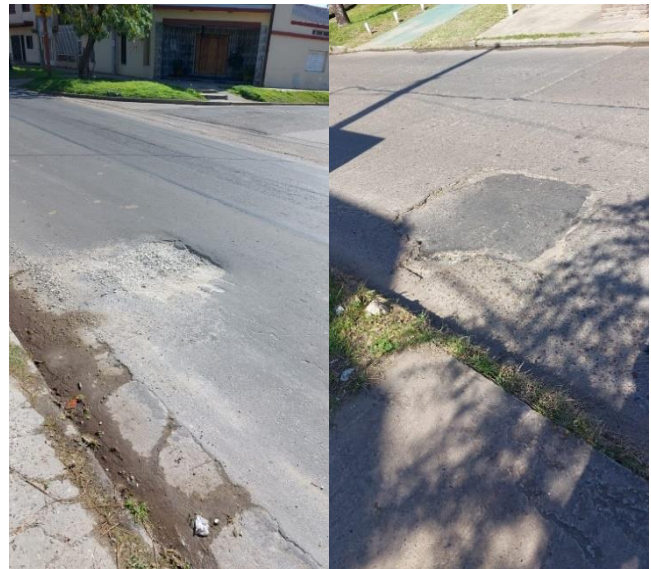
Fig. 10. Pothole at the intersection of Coronel Martinez Street.

Fig. 11. Pothole at the corner of Virasoro Street.

These two pictures below show potholes which are found on Gutierrez Street. The first one is at the intersection of Coronel Martinez Street (Fig. 10). This pothole is very deep because many cars drive over it. The second picture is at the corner of Virasoro and Gutierrez Streets (Fig. 11). In this pothole there is a patch, but it has sunken because there is heavy traffic at this intersection. At night, this street is very dark so these two potholes are dangerous to the cars.

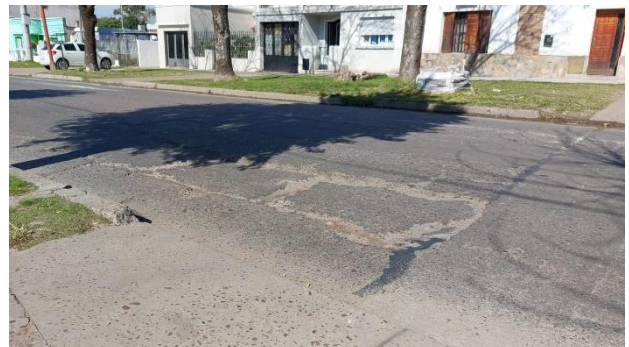
Fig. 12. Central Gutierrez Street, between Virasoro and Piran Streets.

The next picture shows one of the central points of Gutierrez Street, between Virasoro and Piran Streets (Fig. 12). In this image, the problem is more visible because there is a large pothole, and the problem is marked by the lines that surround it. This pothole will be deeper and larger if the problem is not solved on time. The solution for this problem is not a patch because the underlying structure is experiencing failure, so it requires a structural reconstruction.

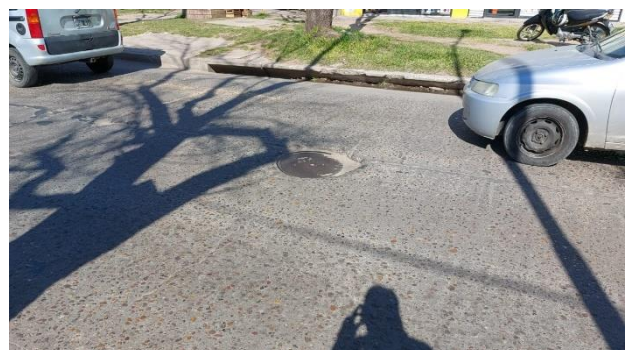
Fig. 13. Storm drain in Gutierrez Street.

There is another pothole located within a storm drain (Fig. 13). In this case, the depth is more evident. If cars drive over it, these could damage the storm drain because of their wheels' impact.
