18th International Conference on
Plasma Surface Engineering

Wear resistance of an Hyperlox Gold® coating over nitrided martensitic AISI 420 stainless steel

Eugenia L. Dalibón¹, Walter R. Tuckart^{2,3}, Sonia P. Brühl^{1,3}

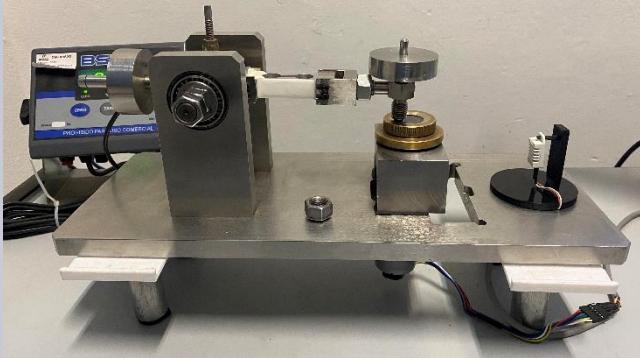
Adhesive
Pin-on-Disk
ASTM G99

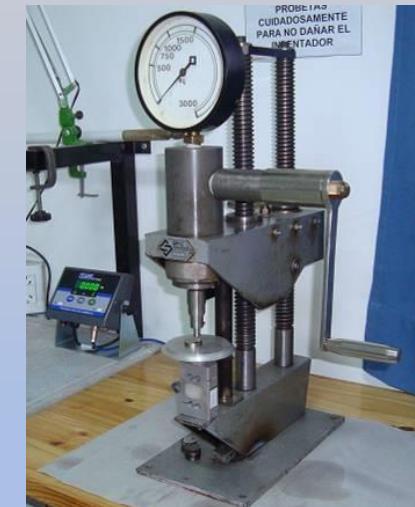
Adhesion
VDI 3198
Rockwell C
Indentation

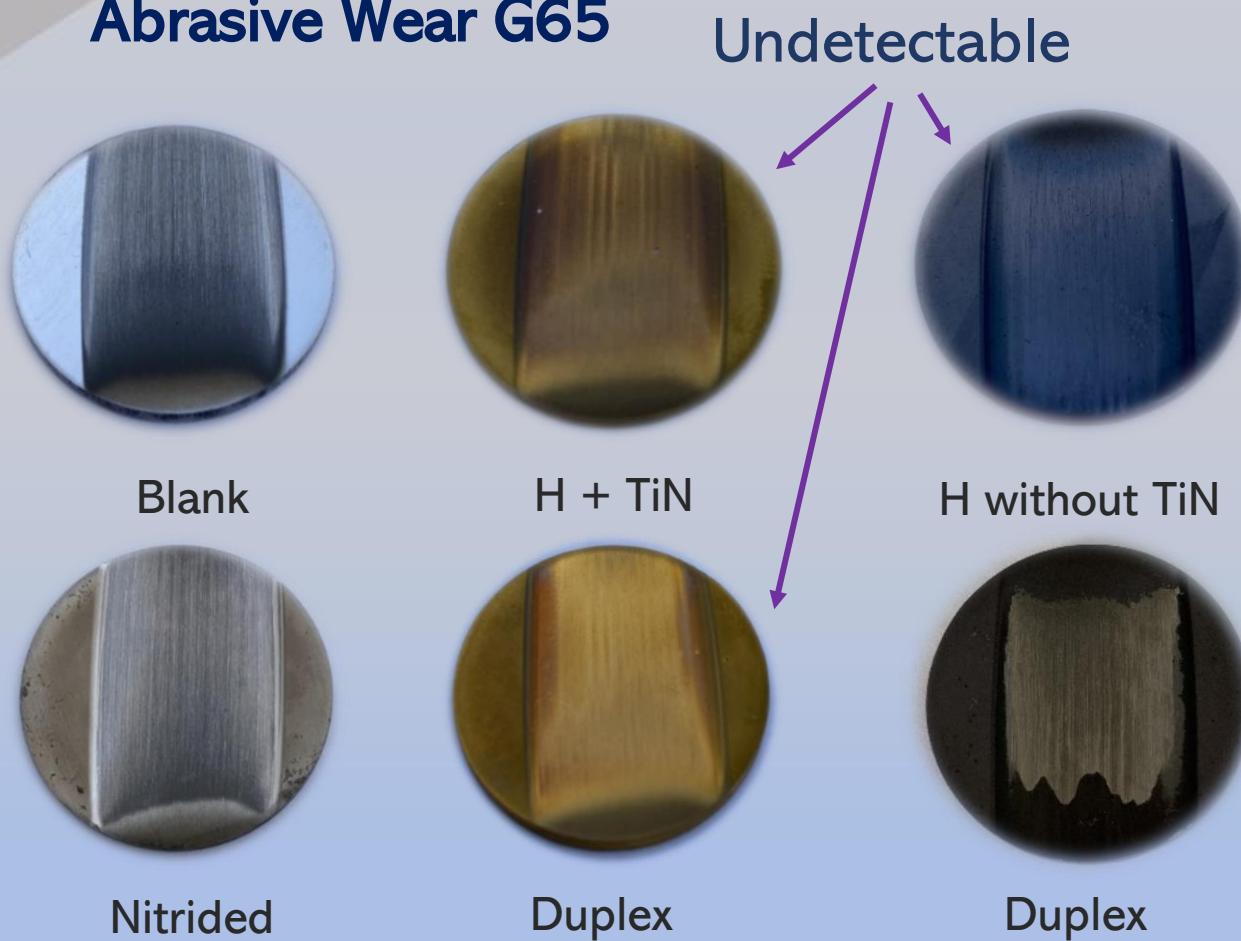
Abrasive Wear G65

1. The Hyperlox and Hyperlox Gold (+TiN) coatings presented a high Young Modulus. However, the hardness of the TiN coating was lower (32 to 26 Gpa).
2. The Hyperlox (without TiN) failed at the abrasive test when it was deposited without the nitriding pre treatment. The same occurred in the POD tests at high loads.
3. The nitrided layer improved the wear resistance in adhesive pin on disk test at high loads for both coatings.
4. The adhesion was better in the duplex samples (nitriding+coating) in both cases.
5. The duplex sample N + H + TiN resulted to be the best protective system in saline environments, proved in the corrosion tests.

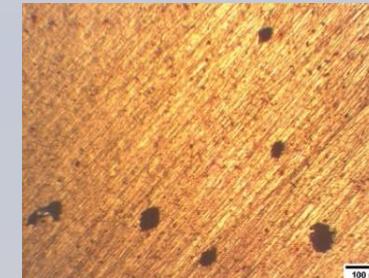
Before

After

N+H+TiN

Pits
OM images
In the same
area

H
