Historic Masonry

*Noemi Graciela Maldonado, Pablo Martín,
Gerardo González del Solar and María Domizio*

Abstract

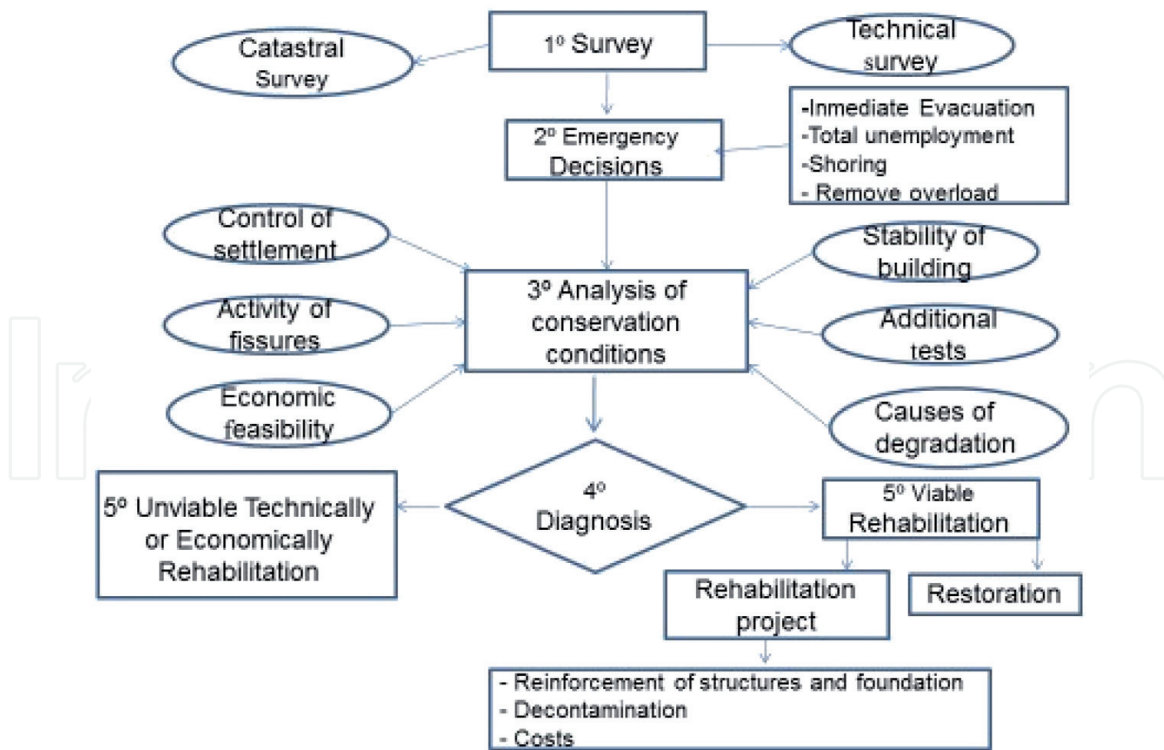
Figure 2.
 Procedures of study of heritage construction.

Figure 2 presents the different steps of the procedures followed for the rehabilitation of historic buildings, applying safety criteria stated in the regulations and conservation criteria of the International Council on Monuments and Sites (ICOMOS) charts [4]. In this evaluation, the impact of the durability of the materials and the environmental sustainability with the built environment must be incorporated in addition to the safety in the structure.

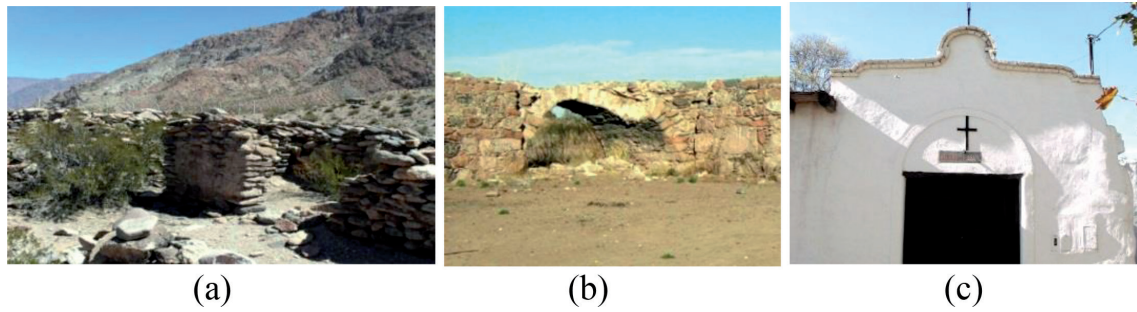
Figure 4. Photographs of Mendoza, Argentina: (a) prehispanic stone walls (Uspallata), (b) stone bridge (Luján de Cuyo), (c) Jesús Nazareno church (Guaymallén).

1. Irregularly shaped and sized but generally laminar pieces are selected and placed by hand in an interlocking mass (e.g. dry stone walls, see **Figure 4**).
2. Medium to large blocks are made or cut very precisely to one or a small range of interlocking sizes and assembled to a basic grid pattern either without mortar or with very thin joints (e.g. ashlar or thin-joint).

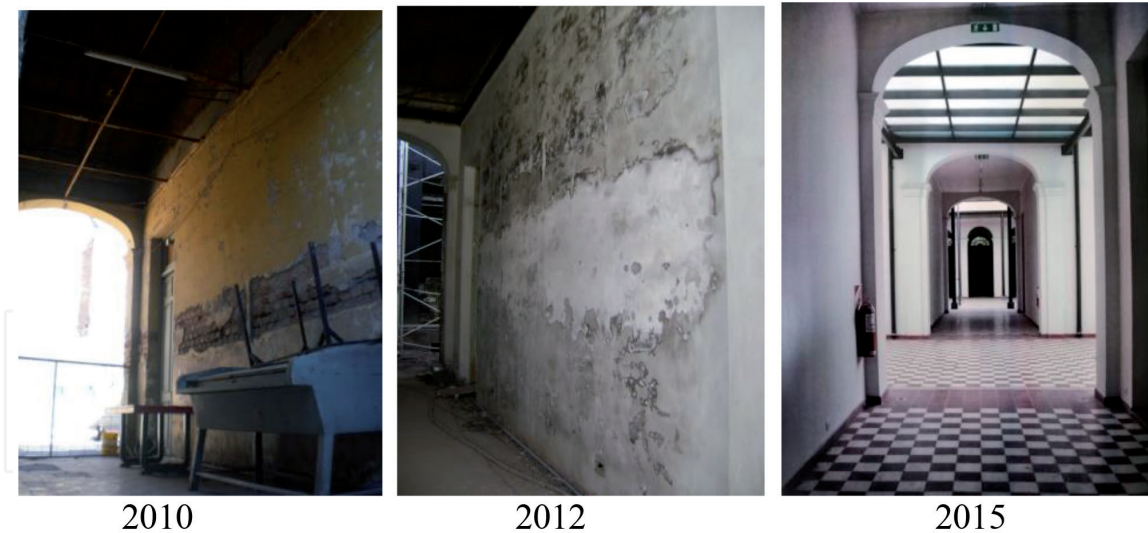
Figure 6.
Evolution of the mortar compatibility process during rehabilitation of school building [2].

As far as mortars are complex systems, different approaches can be used for their characterisation. Nowadays, the reconstruction of the original composition is quite complex and requires the application of various and complementary techniques. In addition, the technological culture of making lime mortars has been lost, although from the economic point of view they would be of lower cost [7]. The need for mortar compatibility has led to the design of specific products to avoid damage by chemical reactions as shown in **Figure 6** [2].

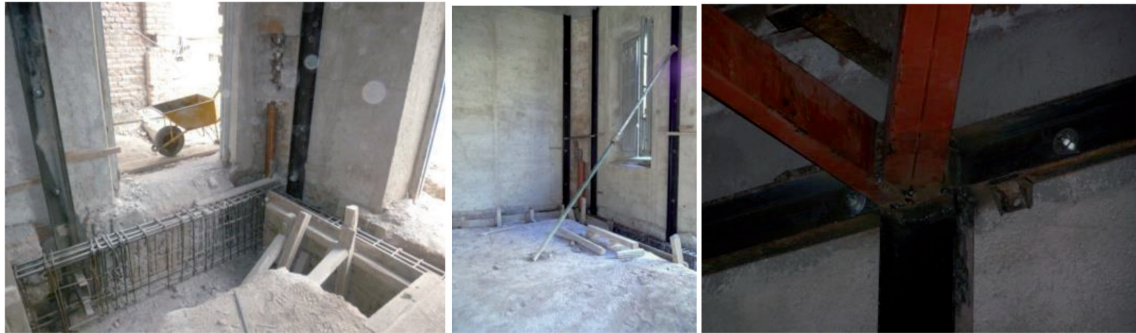
Figure 11.
Reinforcement of foundations and reversible metallic structures in columns and lattice, Mitre school, 2012.

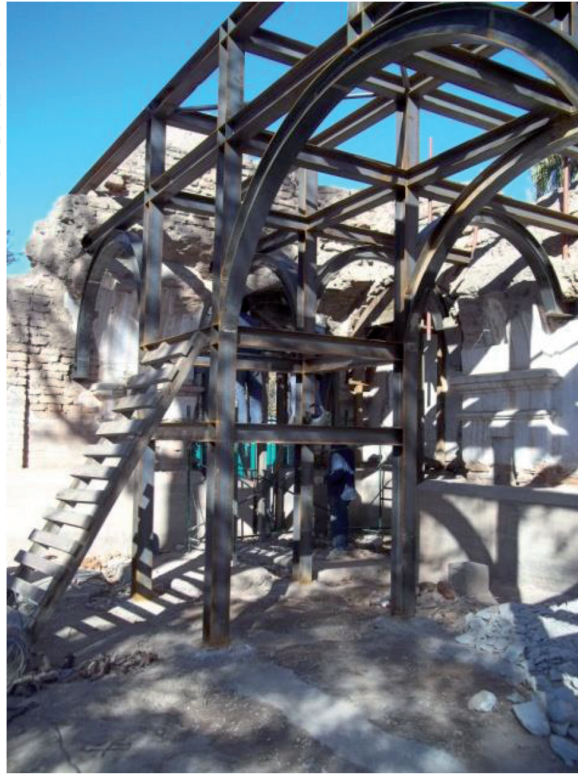
Figure 13.
Support structure of masonry blocks, Saint Francis Ruins, 2011.

- Interventions for the local mechanisms (in case of a prevailing out-of-plane response, **Figure 12**)
- Interventions on blocky structures (where the kinematic mechanisms must be prevented: obelisks, towers and also arches and vaults, **Figure 13**) [19]

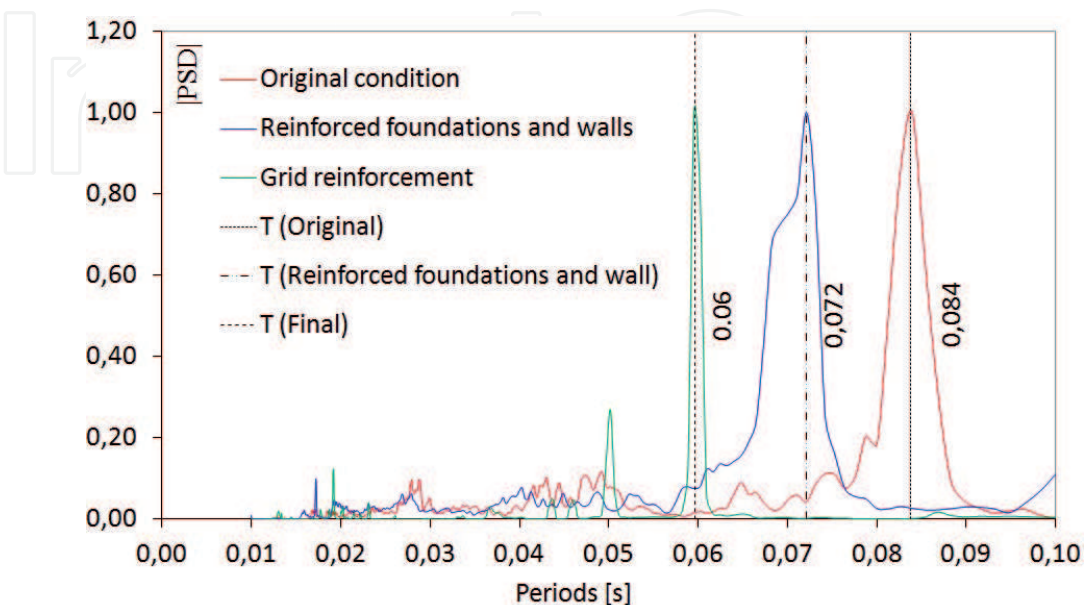
Figure 14.
Evaluation of the change of the dynamic properties of the masonry building in the different stages of the rehabilitation [20].

The effectiveness of a rehabilitation can be evaluated by system identification techniques. They measure the dynamic properties of the structure through environmental vibration before, during and after the structural reinforcement. The vibrations of low amplitude come from different sources, among them, the vehicular traffic, the micro-tremors, the wind, etc.

In the case of masonry, the parameter used to measure the efficiency of the structural reinforcement is the period of the walls measured at the top of them. Before starting the reinforcement work, the environmental vibration in the structure is measured in order to know the periods of the same with the existing level of damage. Once the foundations are consolidated and the walls reinforced, new measurements are taken, and in this way we can know the degree of recovery that the structure has had up to that stage as indicated in **Figure 14** [20].
