# Inglés I - Skills Integration Project

*Increasing Waste of Water: Breaking of Pipes in the Center of Paraná.*

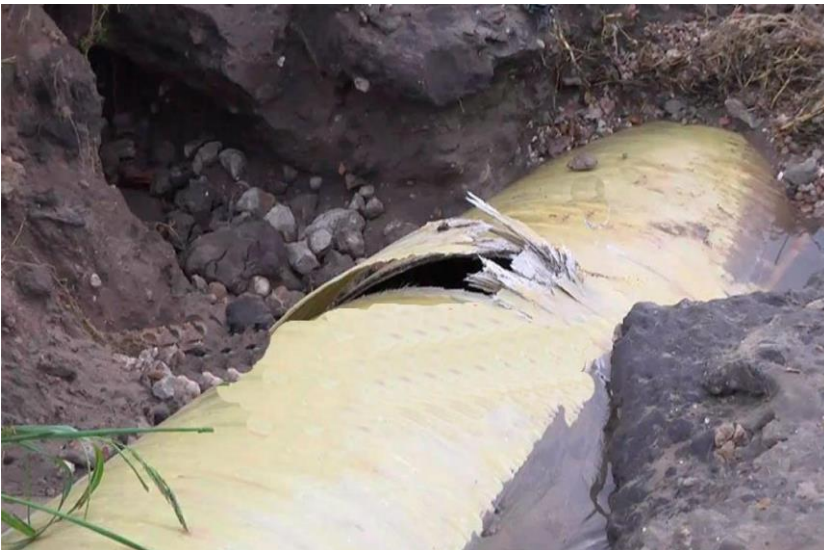
In the following photo we can see a broken water pipe. It is a pipeline located in the center of the city of Paraná.

In the foreground of the image, we can see a damaged pipe. This pipe is made of thermosetting fiberglass-reinforced plastic (FRP). We estimate that it has a dimension of 900 mm, since it is a standard dimension for this type.

On the sides, we can see that there is some soil, so the pipe is buried and has not yet been removed to change it. We believe that this rupture could be caused by overpressure of the water. This occurs because the pipes are old and their size is for lower consumption.

The waste of water in the city of Paraná occurs for multiple reasons. In this presentation we will talk specifically about the waste of water in the city center due to the conditions of the pipes. One of the main causes is that the pipes are old, so they have already fulfilled their useful life and it is necessary to change them. In addition, these pipes have a smaller dimension than they should, since they were calculated for lower consumption.

Currently, the population of Paraná has grown, so consumption has also increased. Therefore, the causes of the losses of the pipes are aging and inadequate infrastructure for current demand.

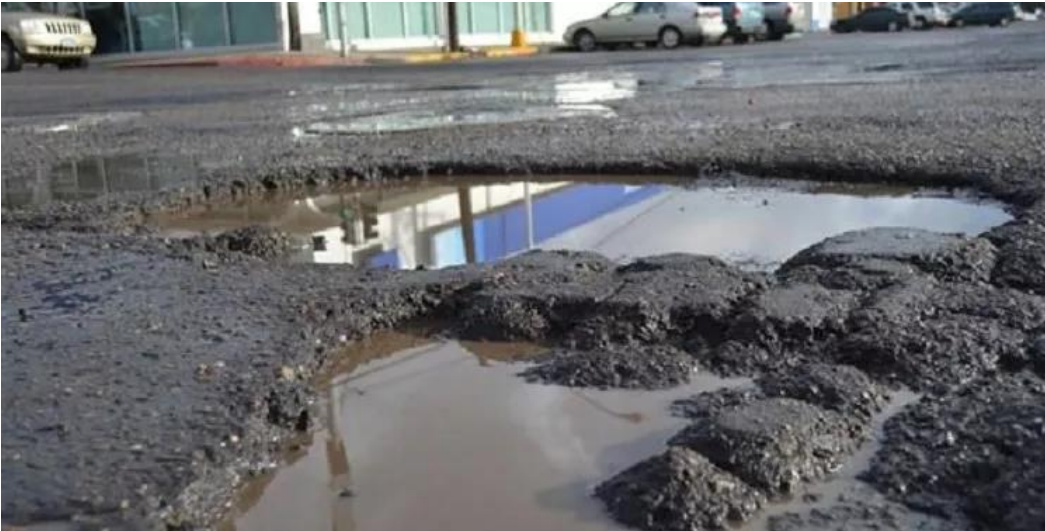
In this photo we can see potholes in the street of a city. These potholes are filled with water.

In the center of the image, there are potholes with water that make traffic difficult. We cannot see this, but we believe that these potholes are generated because there are broken drinking water pipes underneath. In addition to damaging the street, there is a waste of drinking water of approximately 50%.

In the upper part of the image, we can see some cars that are parked. It may be that the image was taken in the center of the city because there are some shops. Vehicles circulating along this street should go slowly because potholes can damage the car.

Broken pipes mainly cause waste of drinking water. This is unfavorable since it is water that has previously been treated at the Paraná water treatment plant. In addition, as the pipes are buried, broken pipes damage the pavement which is above them, when they start to make potholes. This brings about traffic problems, because vehicles must slow down as they can damage the tires or the car itself. Likewise, the municipality must invest in making those repairs that could be avoided by fixing the pipes when they break immediately, which is difficult because the pipes are underground, as we said before.

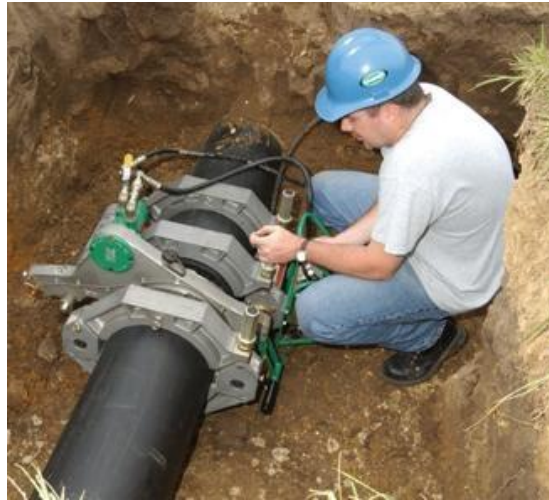
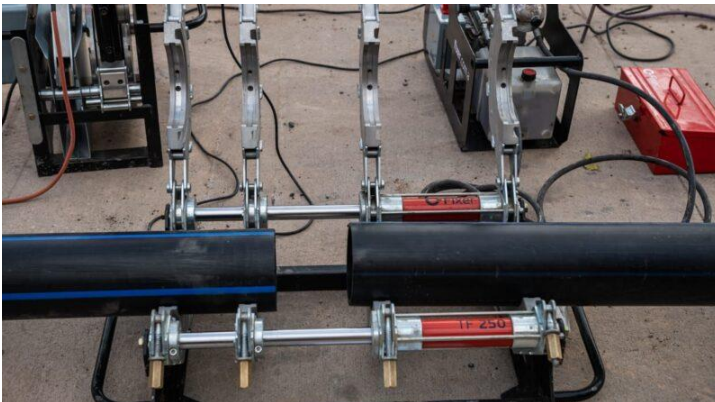
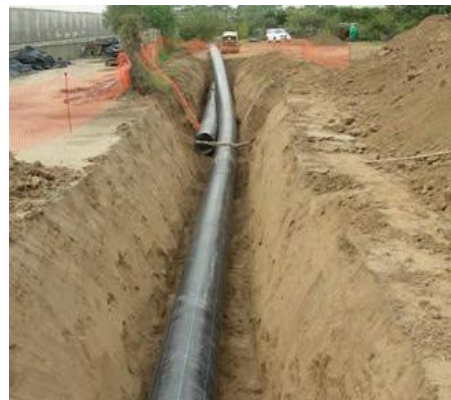
The new pipes will be made of hot-melt PAD (high density polyethylene), using a new technology that does not break streets and sidewalks because it is made with a tunnel that pierces the ground and also avoids encountering sewage and gas pipelines.

This material is better than the currently used material because there is no rust or corrosion and it has a longer lifespan. For it to last longer, it is important to carry out the necessary and adequate maintenance to avoid possible leaks in the pipes.

The new pipes have many advantages. One of the benefits of these new pipes is a better use of water, due to the material of the pipes and their joints. Since they are thermofused, they are less likely to be damaged or have leaks. Added to this, its form of repair is more dynamic and faster, in case it occurs, since it avoids breaking the streets, so traffic is not affected.
